TECHNICAL REPORT 3439
TEST OF 1/10 SCALE BAY STRUCTURE
REPORT NO. 6
ESTABLISHMENT
OF
SAFETY DESIGN CRITERIA
FOR USE IN
ENGINEERING
OF
EXPLOSIVE FACILITIES AND OPERATIONS

PICATINNY ARSENAL
DOVER, NEW JERSEY

JULY 1966

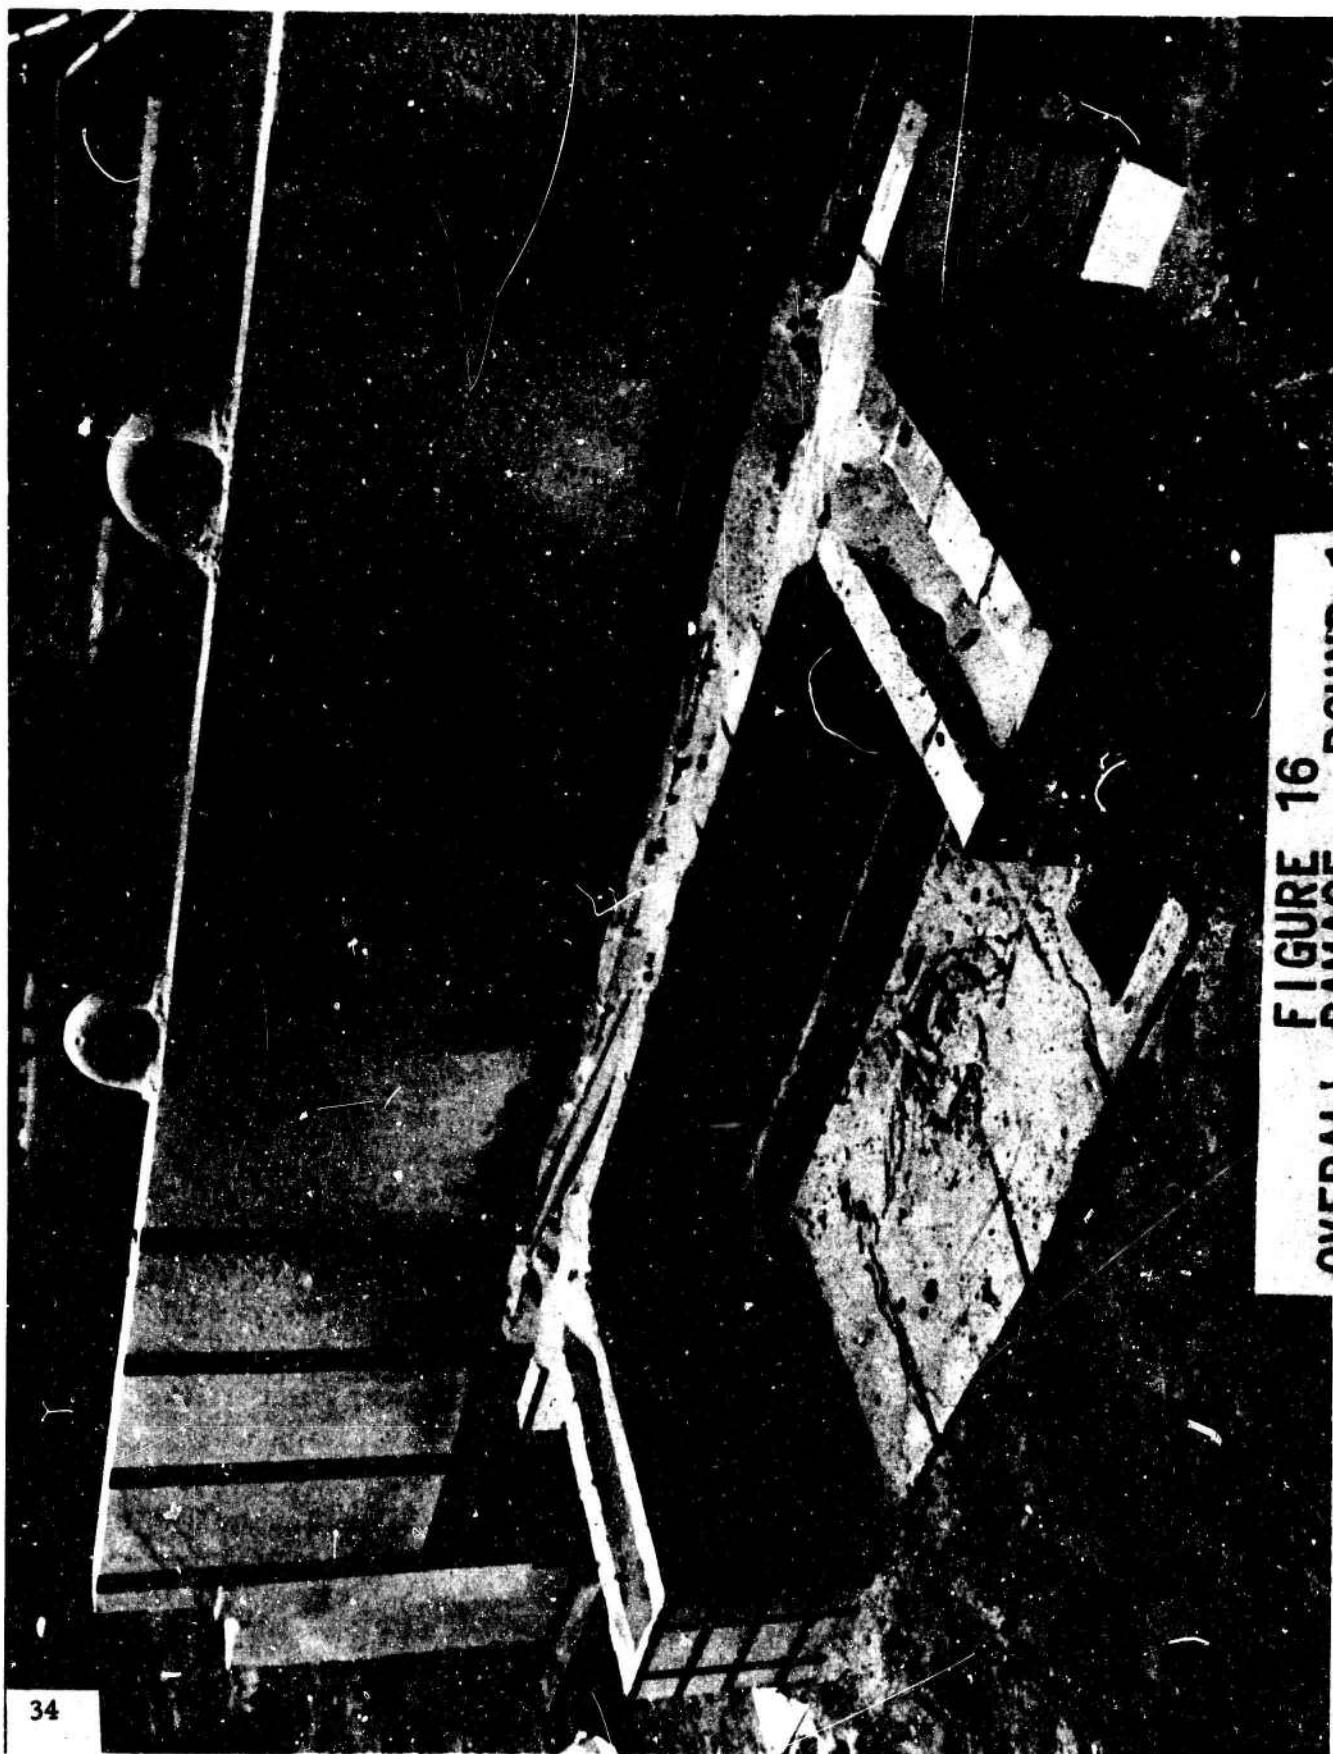
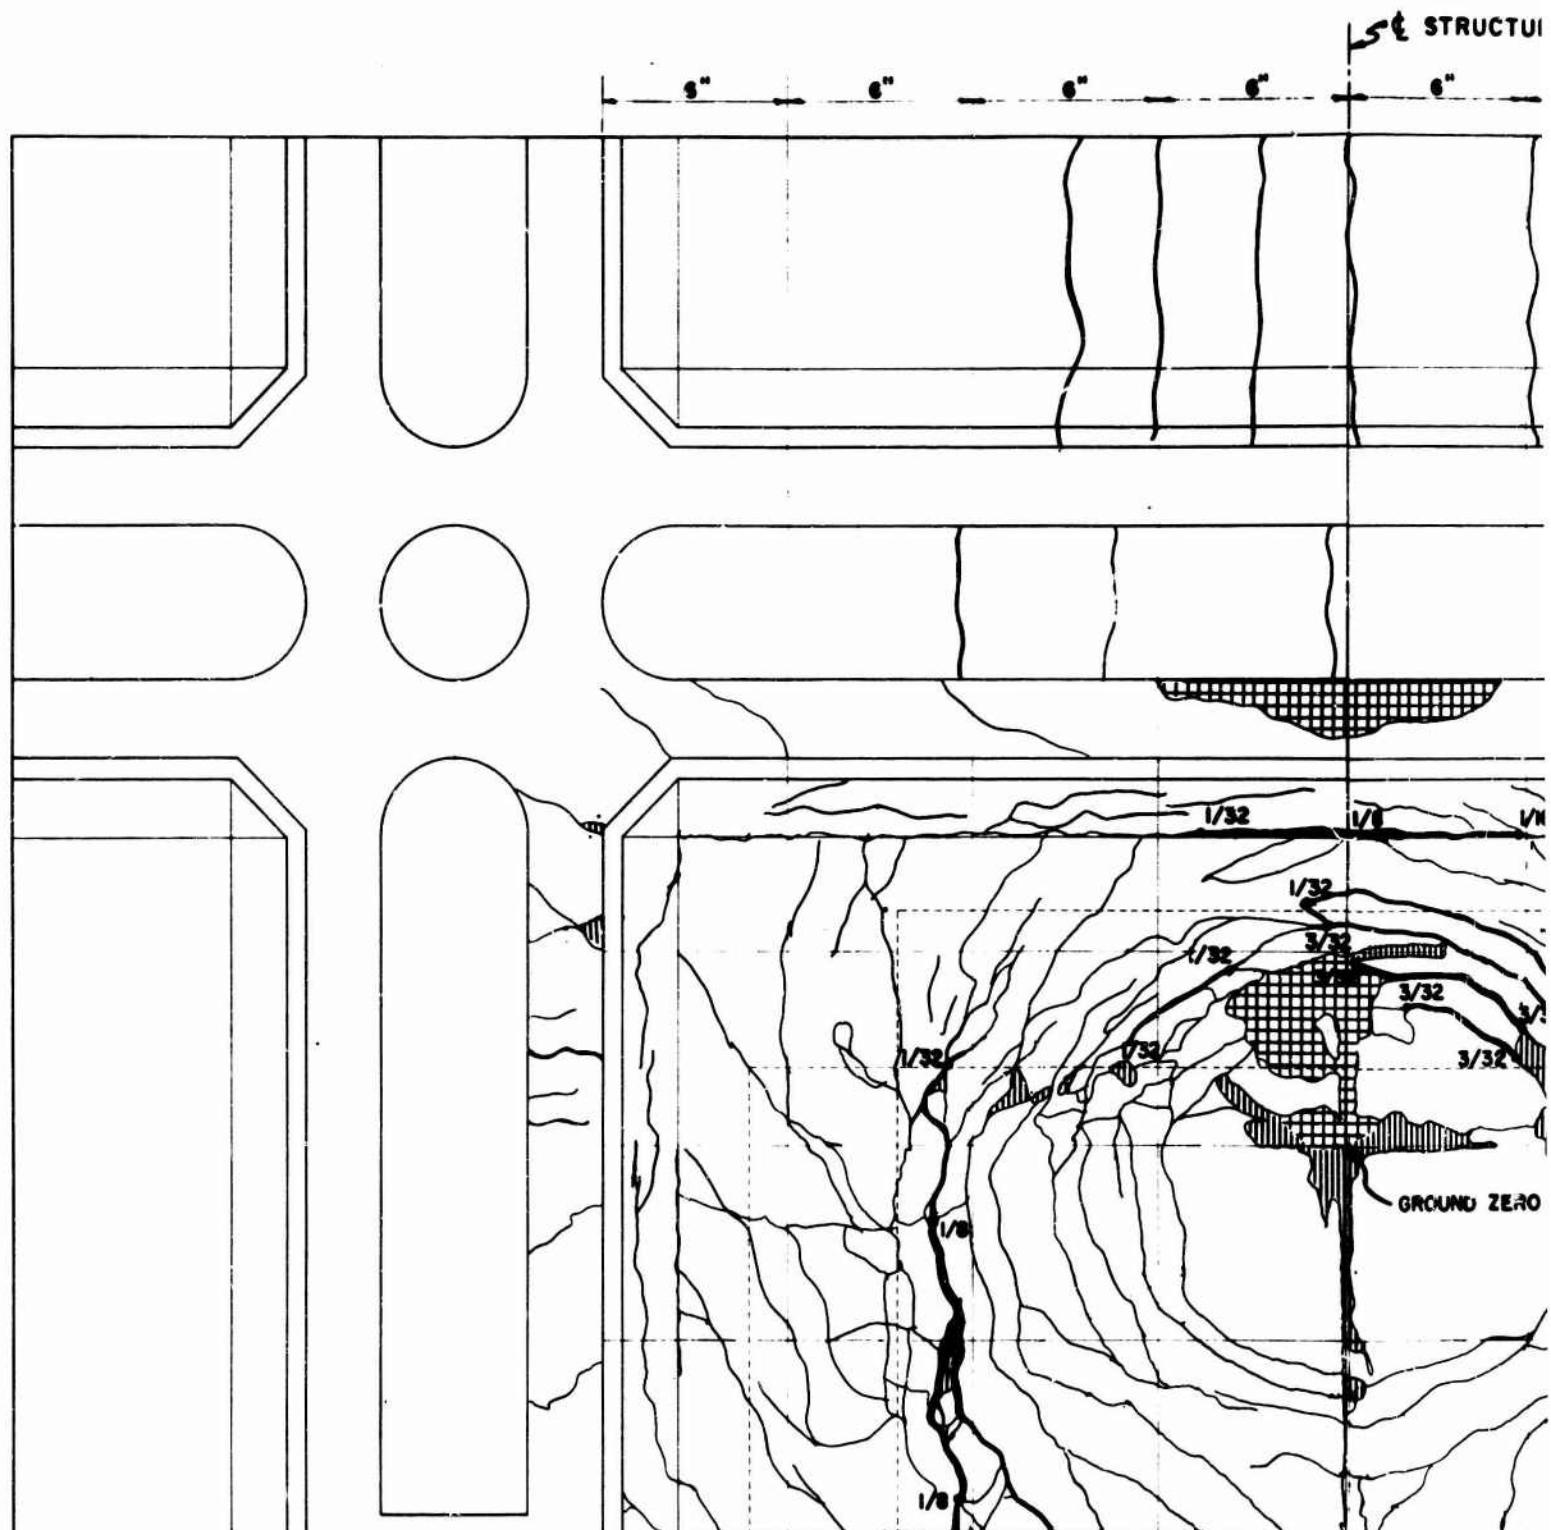
FIGURE 17 NOT
DAMAGE TO STRUCTURE - PLAN VI

Figure 17 and 18 are a plan view and elevations, respectively, of the damage sustained by the test structure.

Floor Slab -- The main damage to the floor slab of the donor cell occurred near ground zero. Spalling of the slab surface took place directly below the charge while slightly greater damage to the floor slab occurred closer to the back wall (Figure 19). At this latter section, the concrete cover was displaced and the reinforcement was exposed at the inner edge of the thinner portion of the slab.

Generally, the floor slab displayed a circular pattern of cracking that followed the dishing action of the slab. The circular cracks were mainly hairline in nature except at the periphery of the damage where the cracks varied from 1/32- to 1/8-inch in width. In addition, some larger cracking was evident at the intersection of Wall 2 (back wall) haunch and the floor slab indicating displacement of the floor slab away from the walls (Figure 17). The total length of the haunch cracks was about one foot and the cracking straddled the center line of the cell.

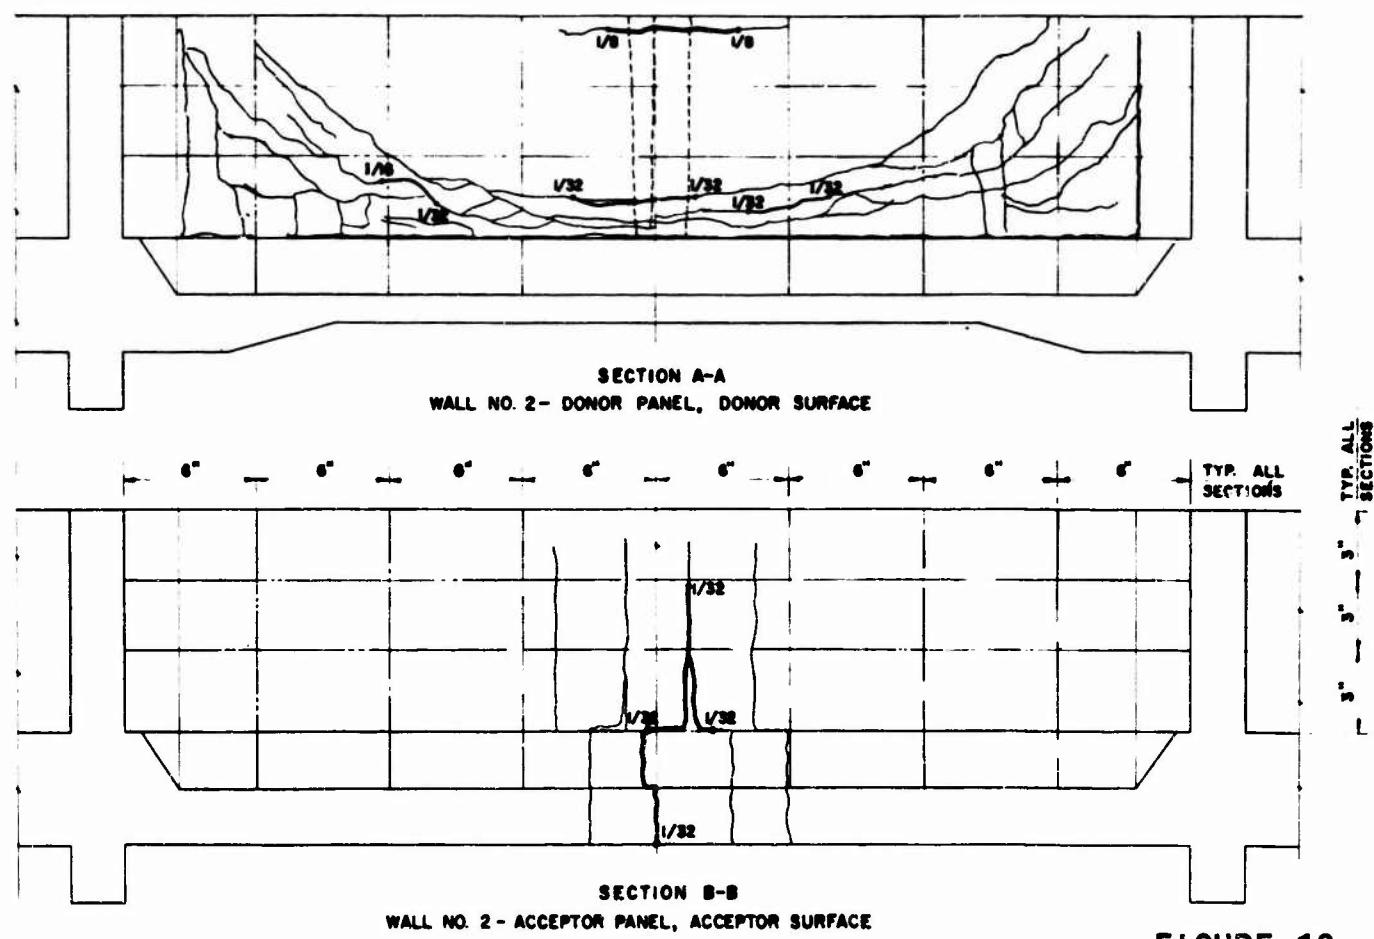
FIGURE 18
DAMAGE TO STRUCTURE - ELEVATIONS - RC

The major damage to the donor panel of Wall 1 occurred at the top of the wall adjacent to its intersection with Wall 2 (Figure 18 and 22). In this instance, 1/16- and 1/8-inch-wide cracks were formed by the relatively large stresses developed at the intersectional area. In addition, continuous hairline cracks were created along the support ends of the donor surface of the donor panel -- at its juncture with Wall 2 and at the haunch (Figure 18). Straining of the donor surface reinforcement (tension reinforcement) was the cause of the hairline cracking.

Like that of Wall 1, the acceptor surface of the donor panel of Wall 3 displayed vertical hairline cracks extending the full height of the wall; but unlike Wall 1, cracks were spread over a large area of the wall (Figure 18).

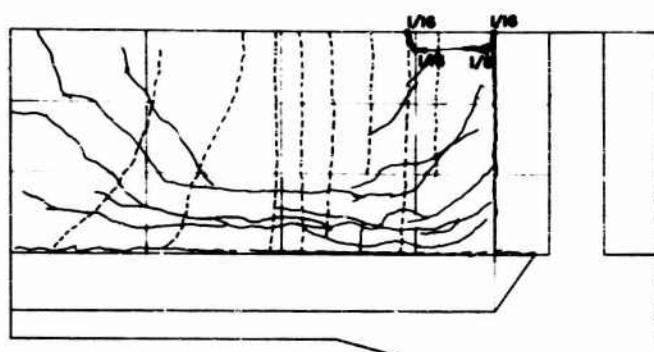
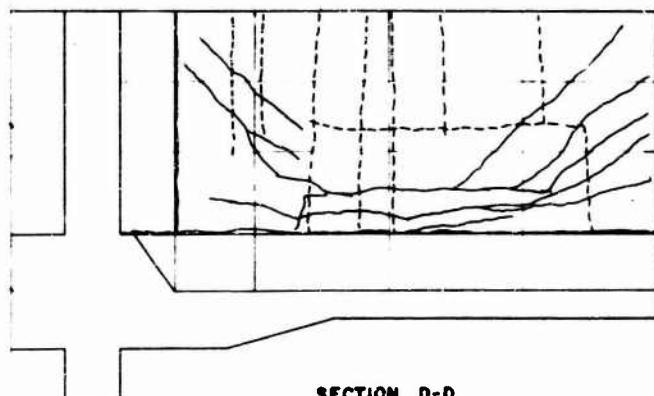
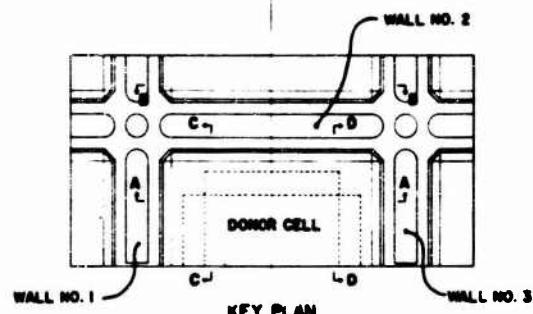
The crack pattern of the donor surface of the donor panel was similar to that of the donor panel of Wall 1 (Figure 18 and 23). In this case the cracking commenced at each of the upper corners where the back wall intersects the two side walls and proceeded diagonally downward towards the center of the wall near the haunch. This pattern is typical of panels supported on three sides (two side walls and the floor slab) and free on the fourth (top of wall). The widths of the individual cracks varied from hairline near the upper

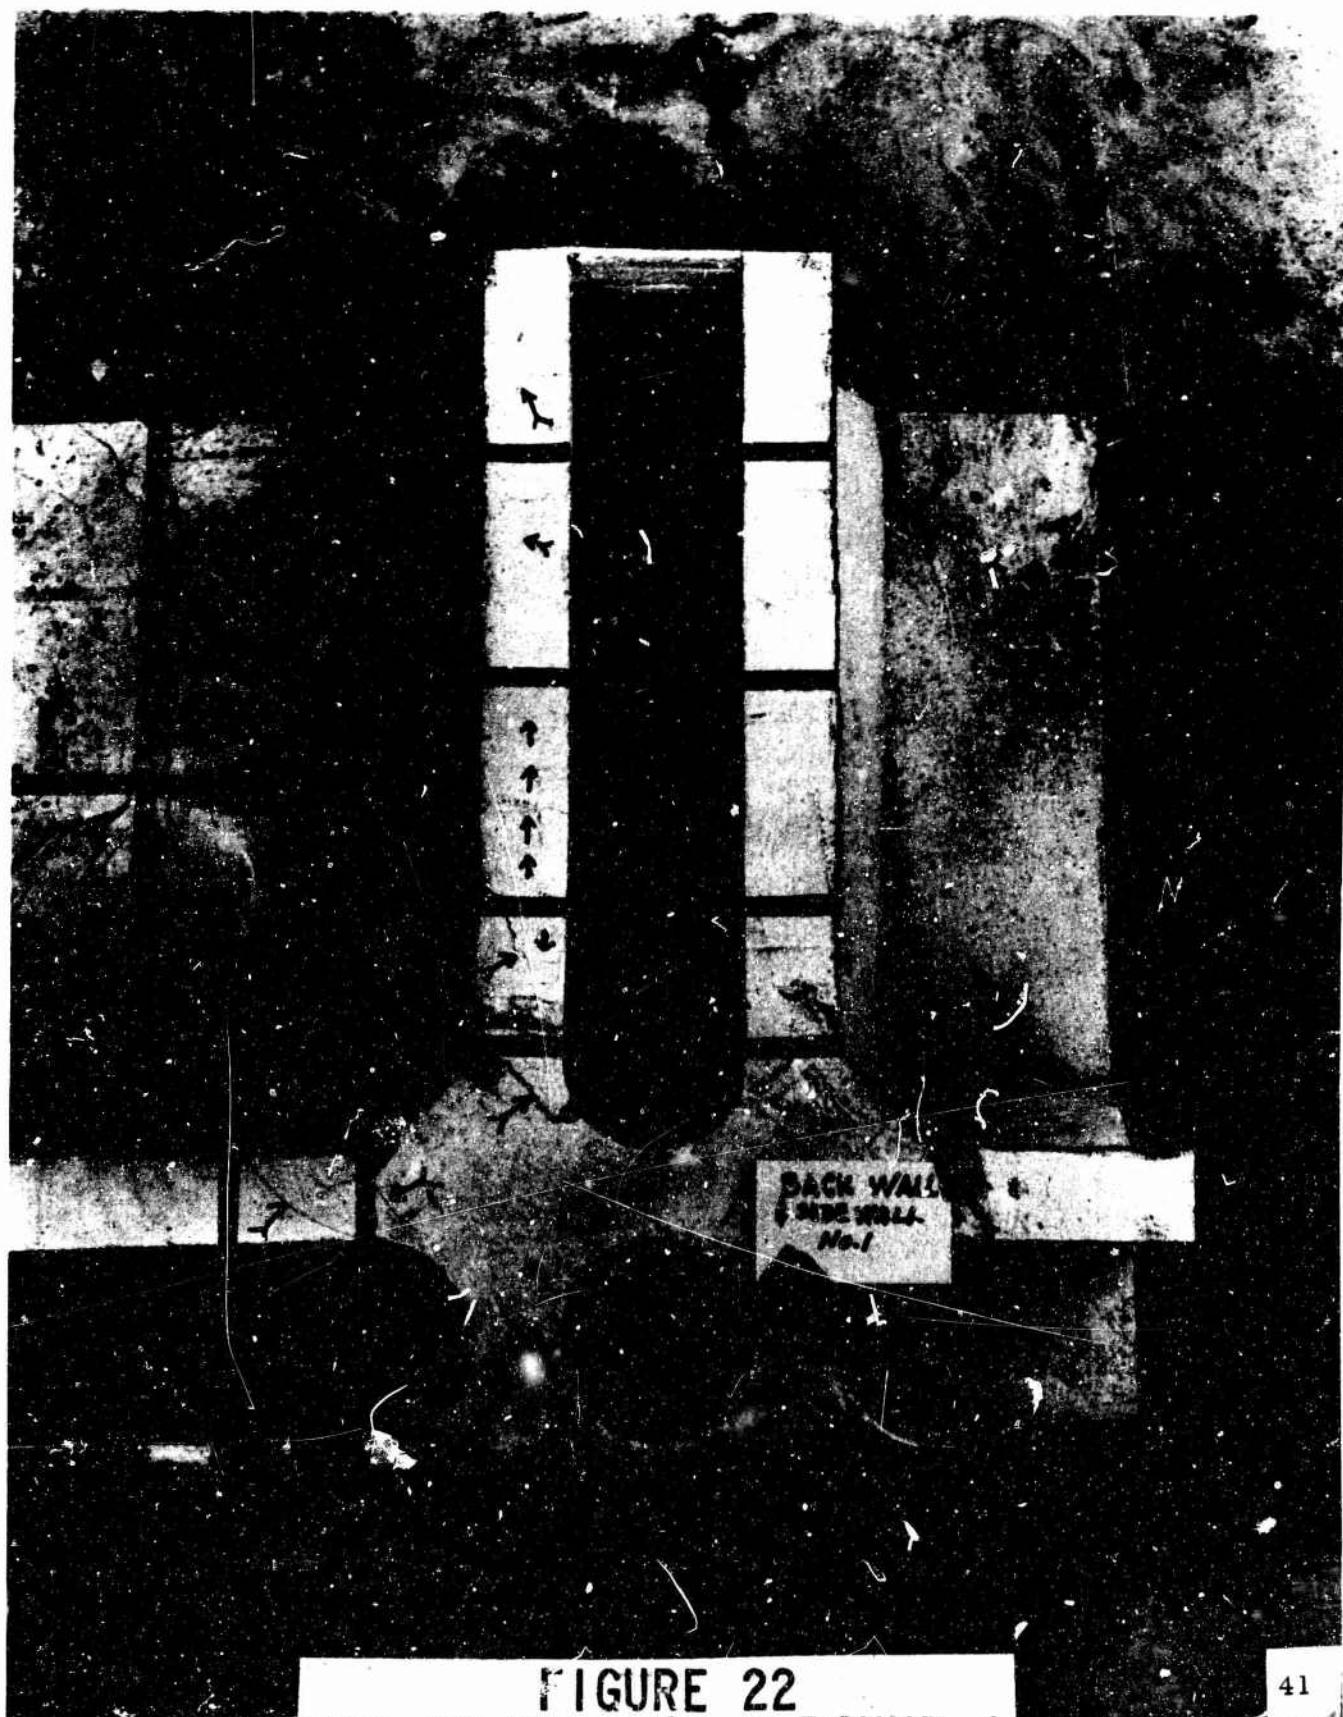
FIGURE 22
TOP OF WALL 1 - ROUND 1

Wall 1 -- Slight damage was sustained by the donor panel of Wall 1 whereas there was no damage to the acceptor panel (Figure 21). On both surfaces of the donor panel, the major portion of the cracks were hairline in size. On the donor surface the general pattern of the cracks was circular and started in the upper corner at the intersection of Wall 1 with Wall 2; from there the cracks proceeded downward toward the center of the wall near the top of the haunch and then extended upward toward the top corner of the wall at the open end of the structure. The circular pattern indicated that a certain amount of support was afforded by the end panel which acted as a shear wall and as a compression strut in transferring a portion of the donor-panel load to the acceptor panel (Figure 22). Only minor cracking of the end panel was evident at its intersection with the donor panel.

On the acceptor surface of the donor panel there appeared a series of vertical hairline cracks extending from the top of the panel to its base in the vicinity of the interior third point of the panel. This cracking was indicative of positive straining of the horizontal reinforcement on this face of the panel.

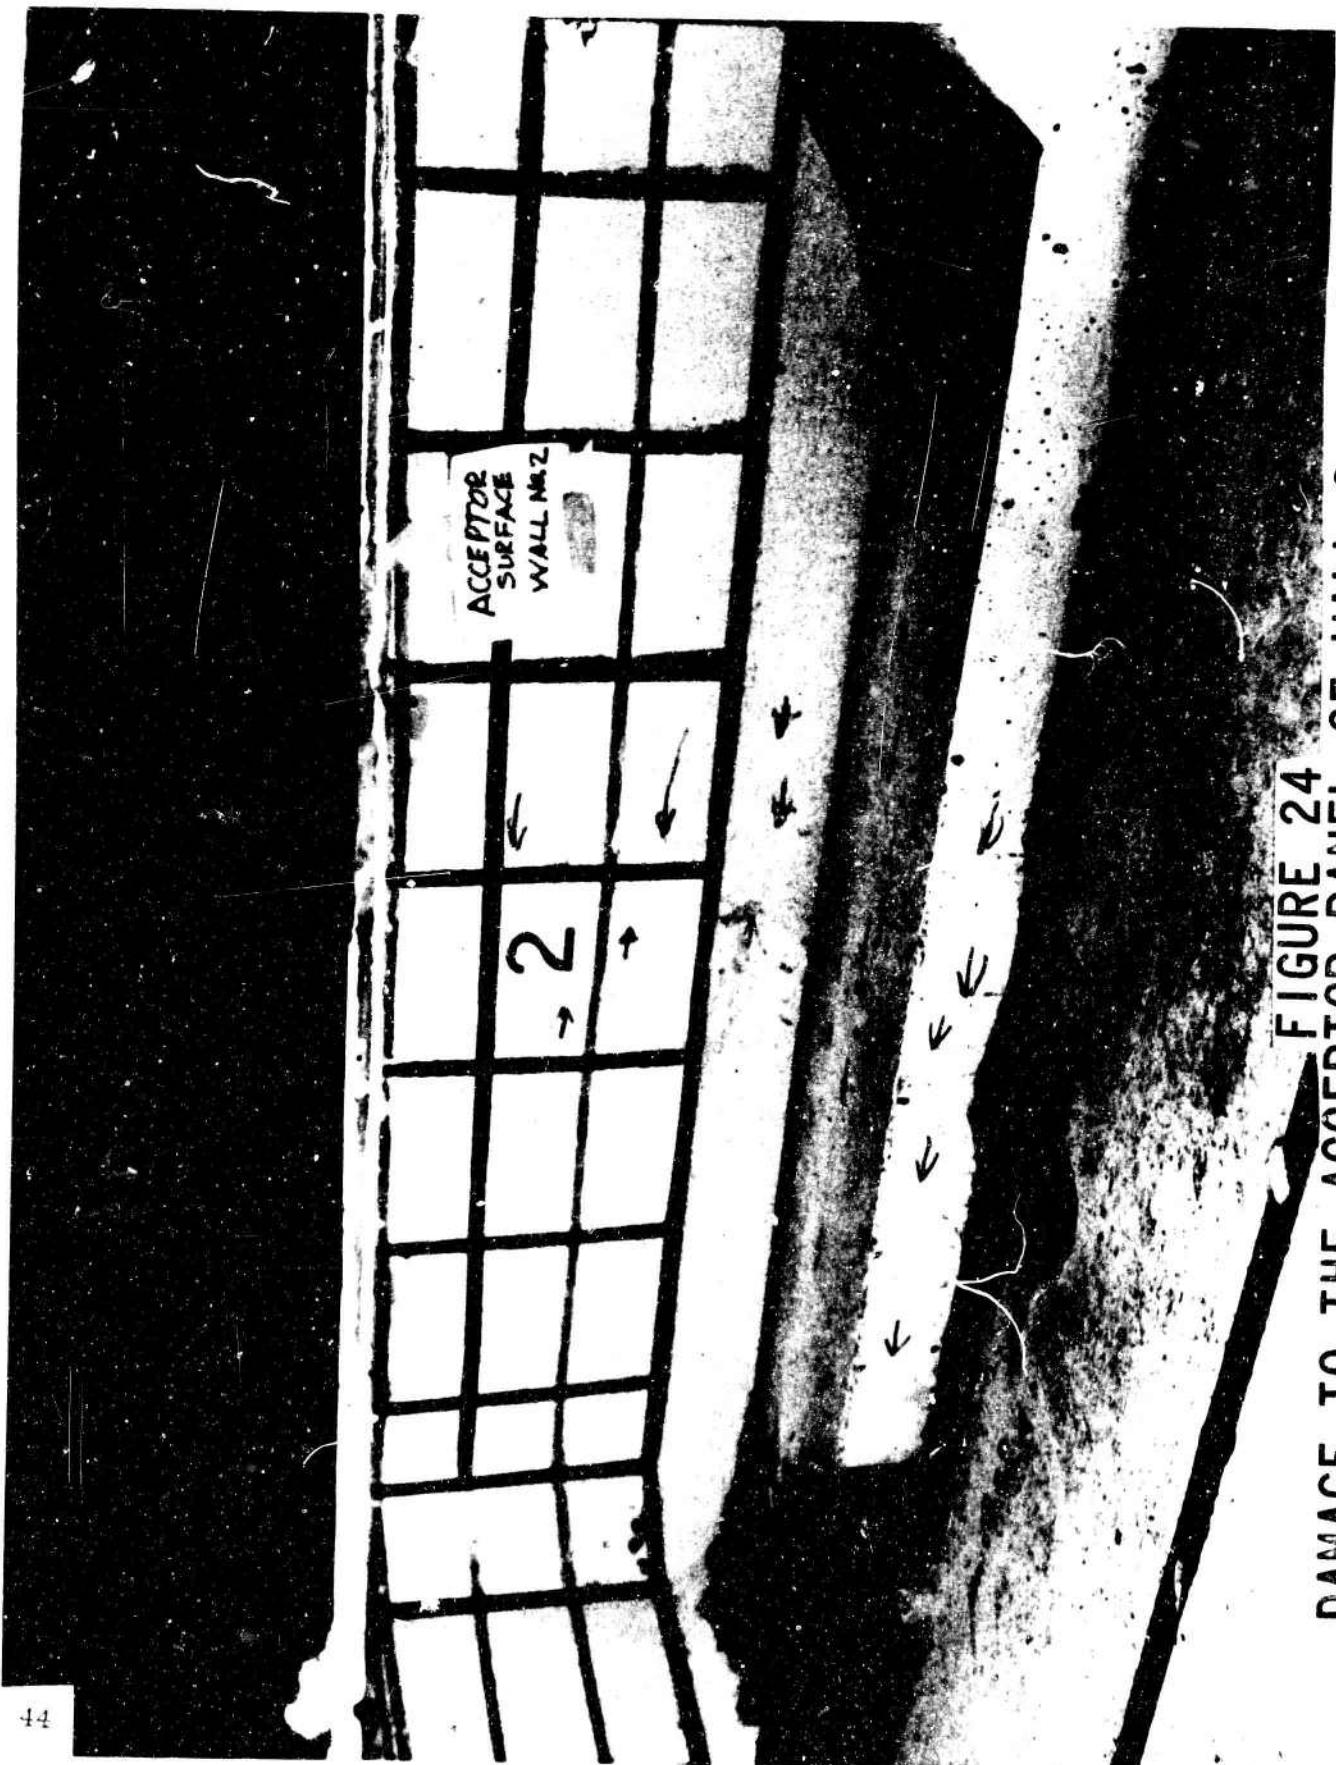
FIGURE 24
DAMAGE TO THE ACCEPTOR PANEL OF WALL 2 - ROUND 1

The main feature of the damage sustained by the acceptor panel of Wall 2 was a 1/32-inch-wide crack near the center of the wall. The crack extended vertically from about six inches below the top of the wall to both of the wall haunches and continued through the floor slab of the acceptor cell of the structure and also through the tie beam separating the donor and acceptor panels at the base of the wall (Figure 17, 18 and 24). In a like manner several auxiliary cracks appeared parallel and adjacent to the main crack and were of the hairline type.

It is theorized that the cracks in the back wall acceptor panel and those in the floor slab of the acceptor cell may have resulted from the horizontal bending action (of the floor slab and the tie beam at the base of the wall) produced by the load applied to the face of the wall proper. However, the settlement of the center of the wall (caused by the floor slab load) relative to the ends of the wall may have produced tension cracks in the lower section of the wall. At this time it is believed that the settlement of the wall was the more significant of the two factors.

It will be seen later that this damage sustained in the acceptor cell of the cubicle was an important factor in the collapse of Wall 2 in subsequent rounds.

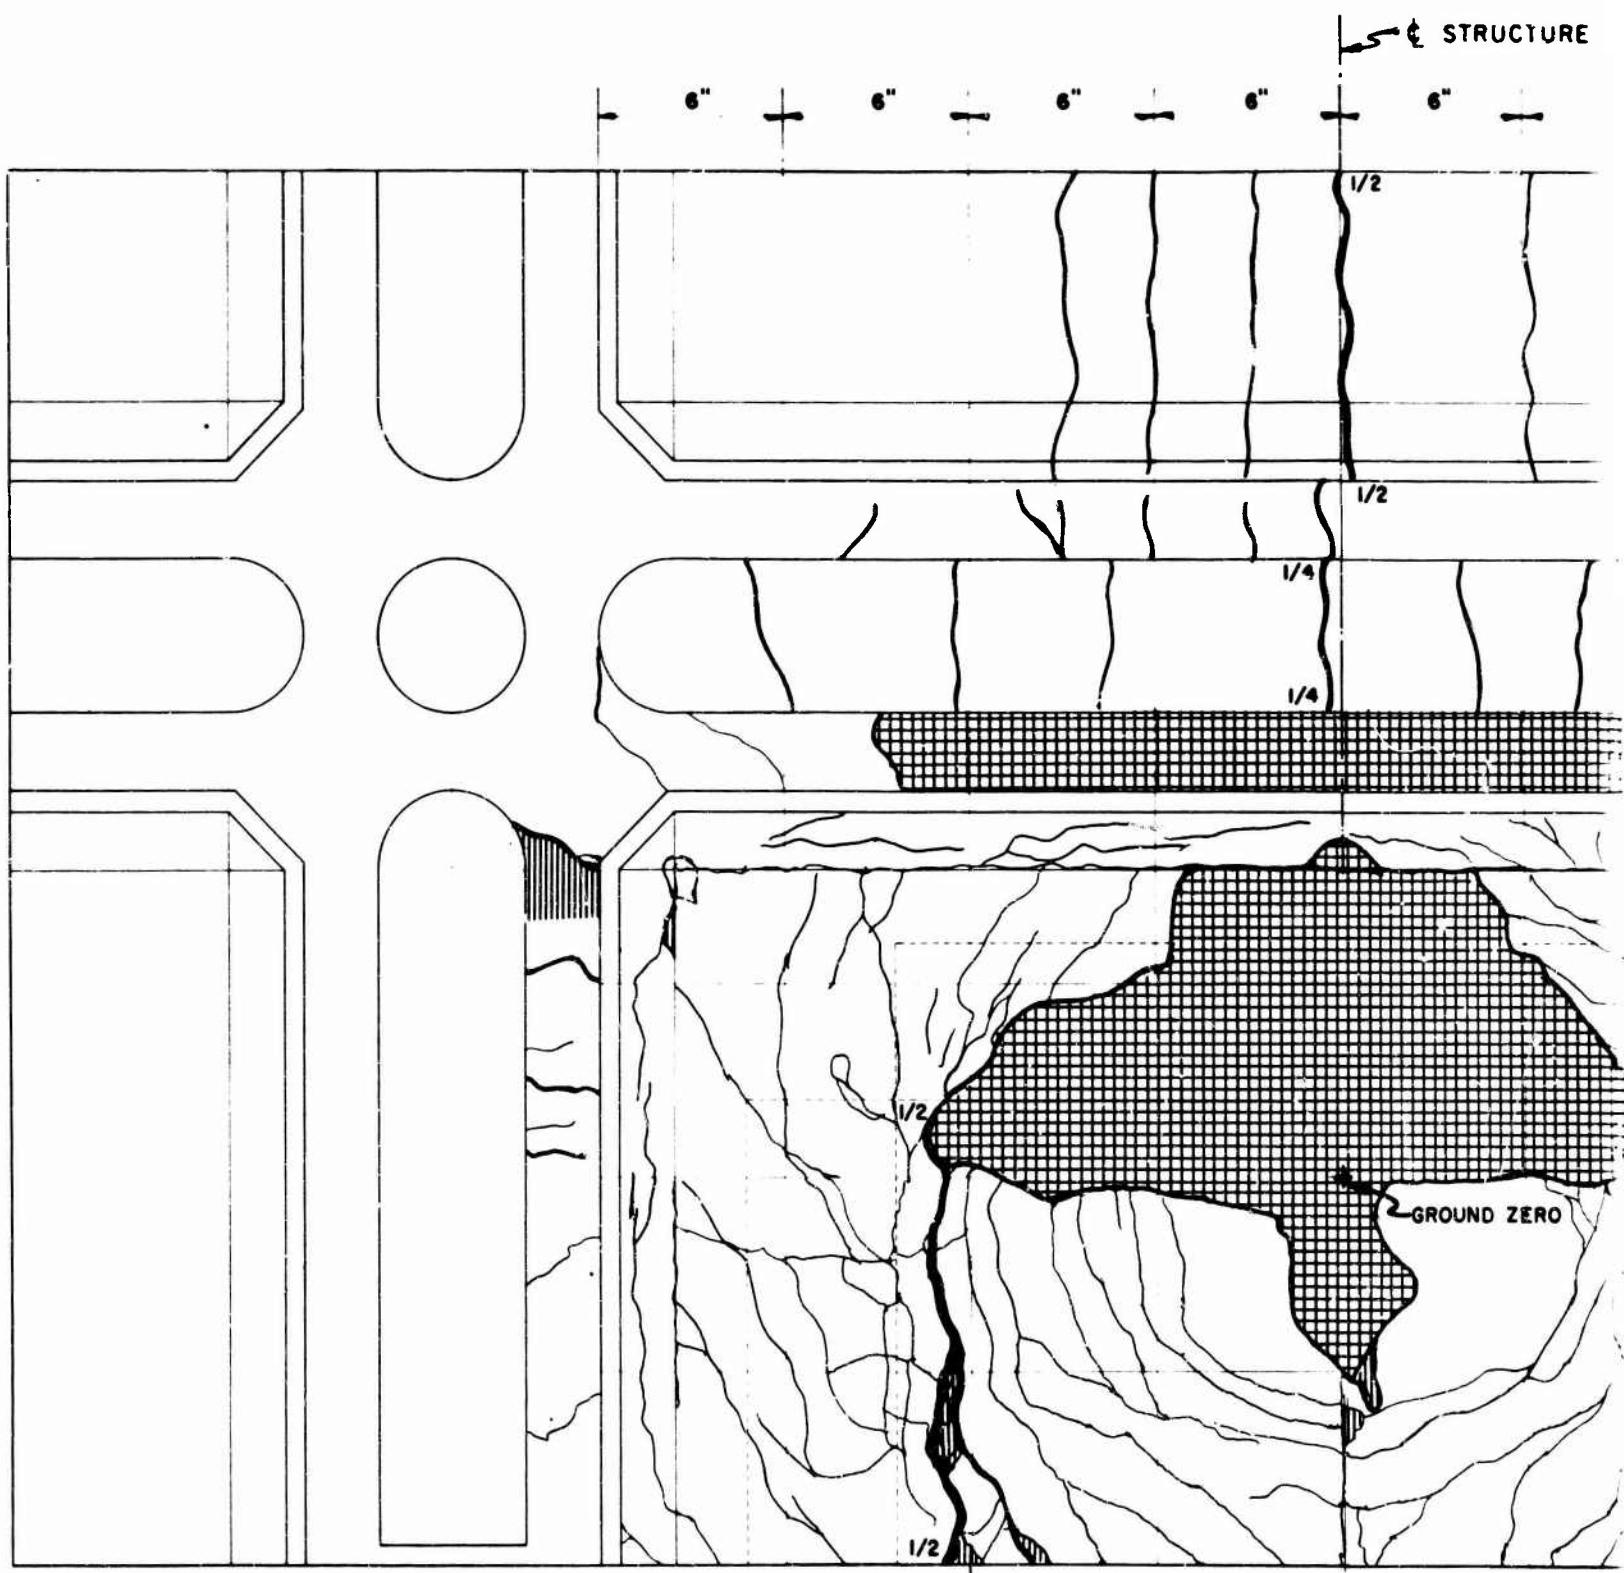
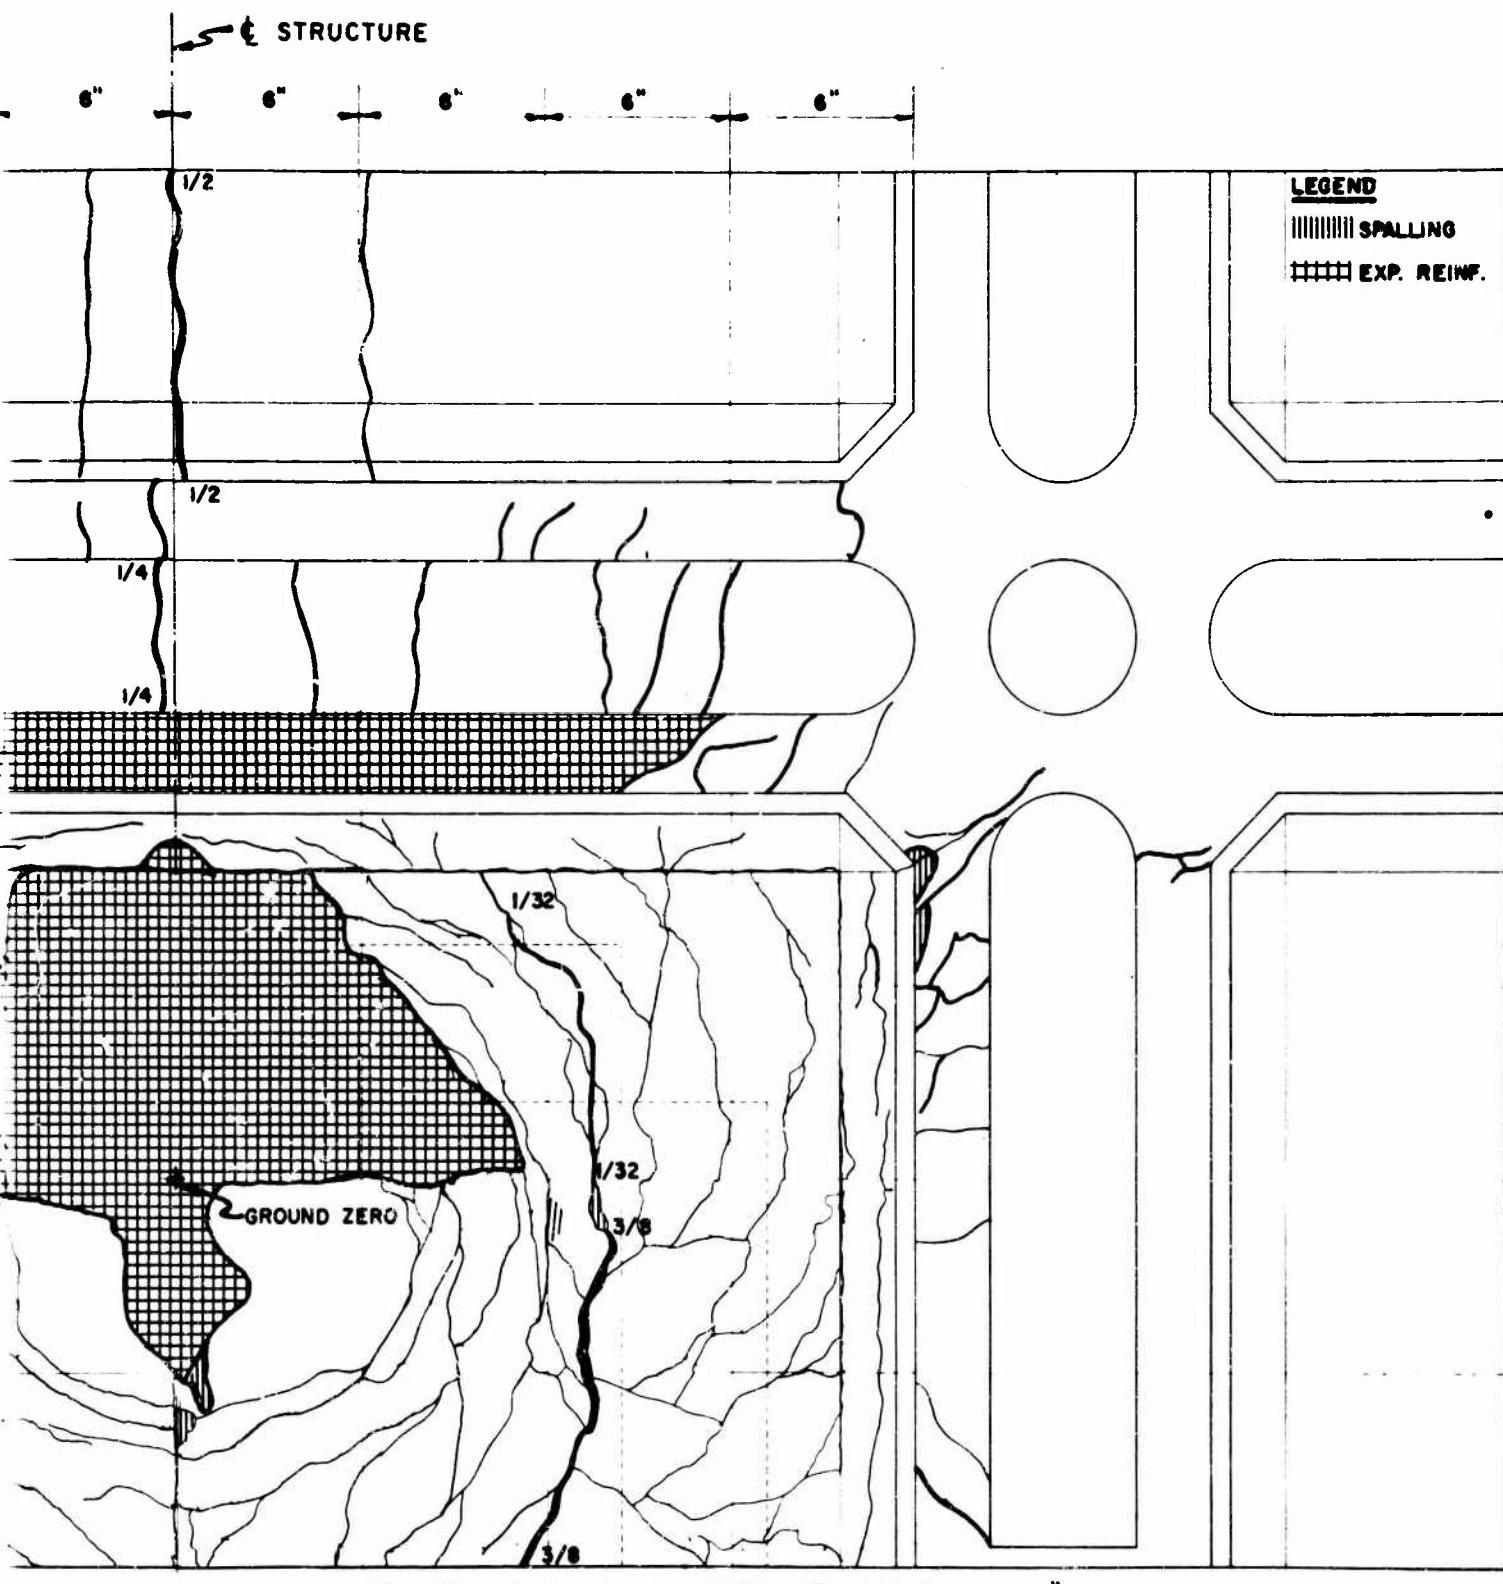
FIGURE 28
DAMAGE TO STRUCTURE - PLAN VIE

Figure 28 and 29 are plan views and elevations of the damage sustained by the structure.

Rupture of reinforcement, fragmentation of concrete and complete collapse (Figure 30) were the chief types of damage sustained by the thin, central portion of the floor slab. Extensive cracking was evident in the thick sections of the slab adjacent to the side walls and also in the haunches of the walls (Figure 28).

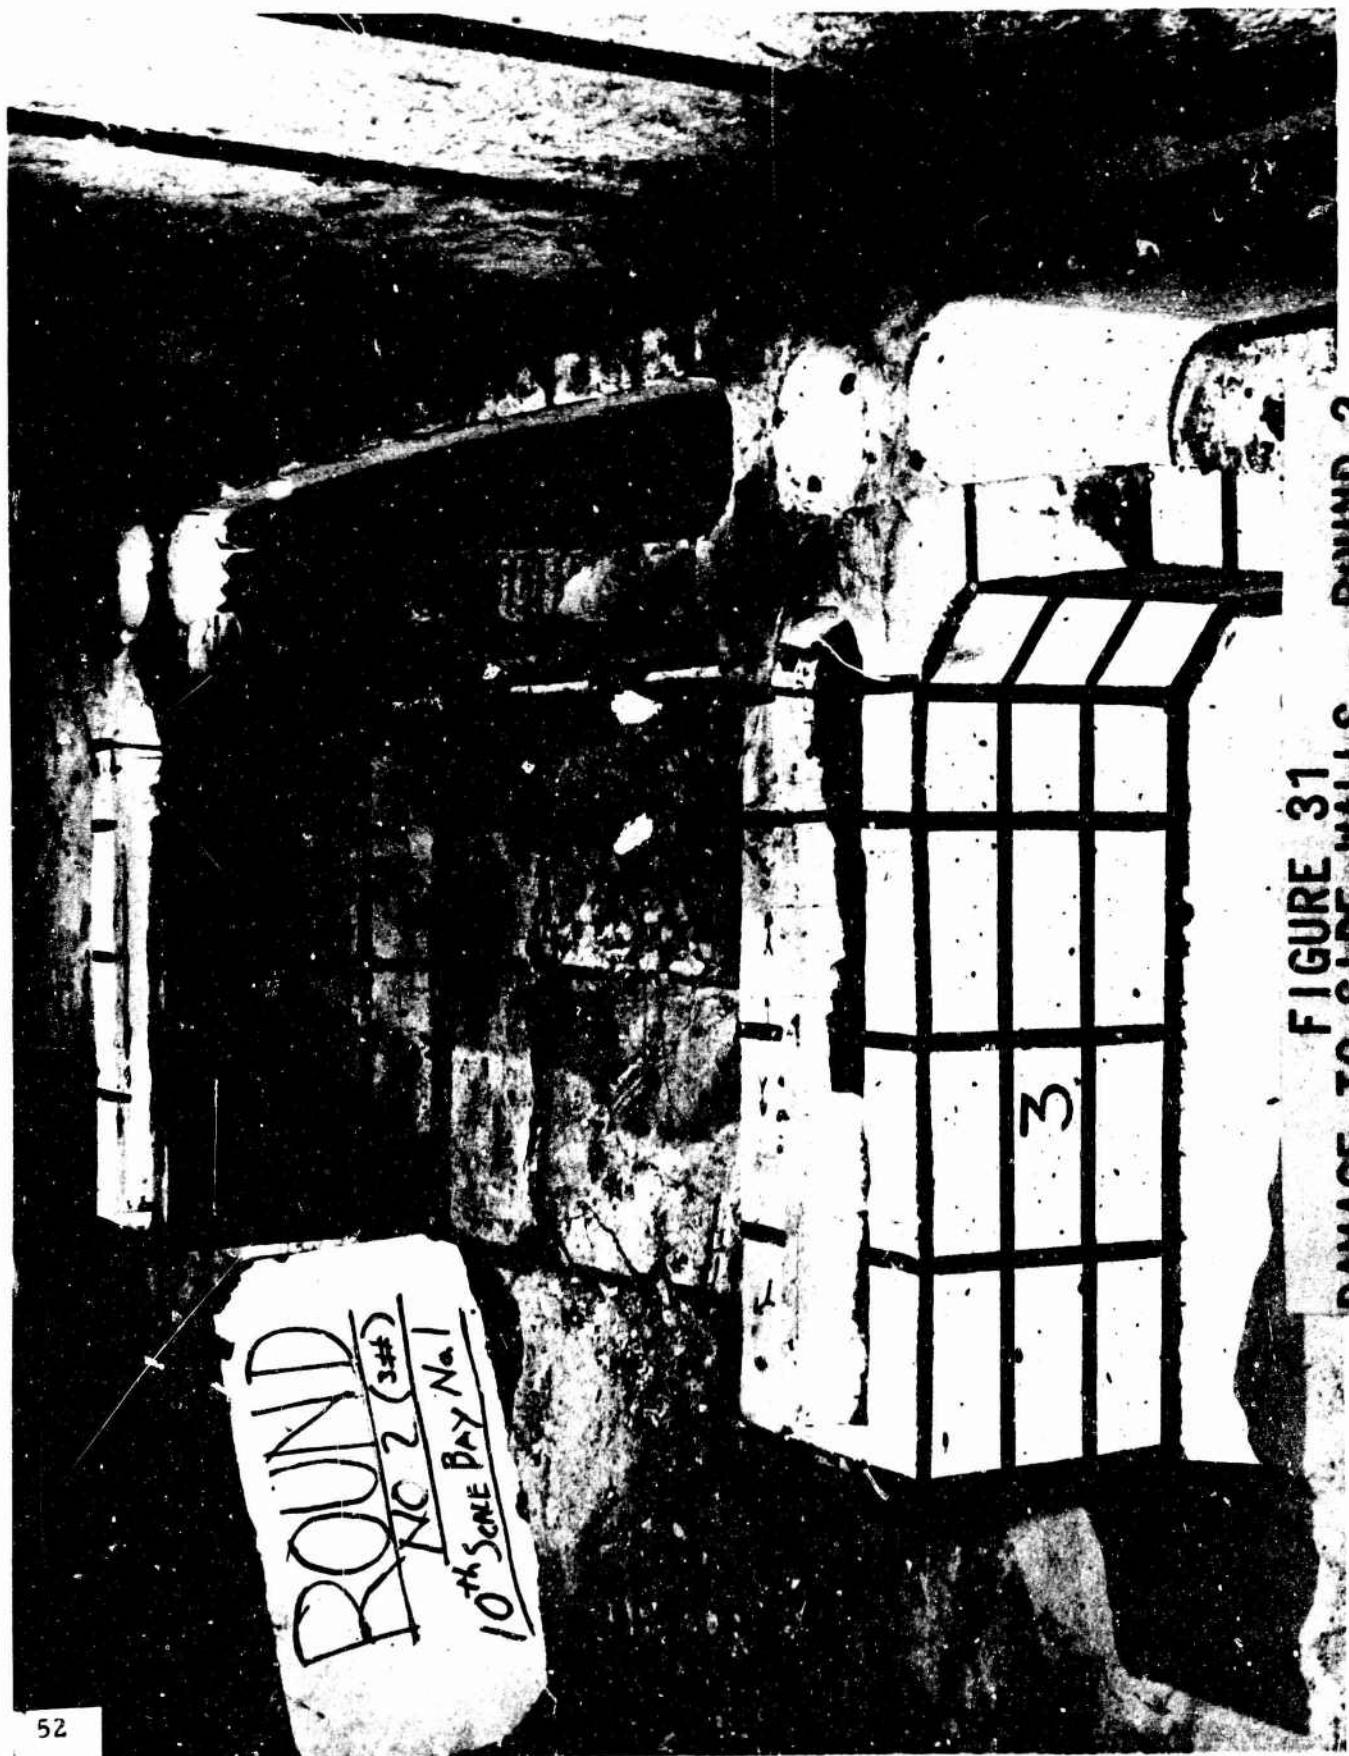
FIGURE 31
DAMAGE TO SIDE WALLS - ROUND 2

On the side walls, damage was more marked on the donor panel of Wall 1 (Figure 31) than on the corresponding panel of Wall 3 (Figure 32), the bulk of the damage being light cracking and small spalled areas in the proximity of the back wall. Deflections of the donor panels were substantially similar in magnitude -- in the order of 1/4 inch. Although the end panels exhibited several scattered fissures, the acceptor panels displayed no damage whatsoever (Figure 31 and 32).

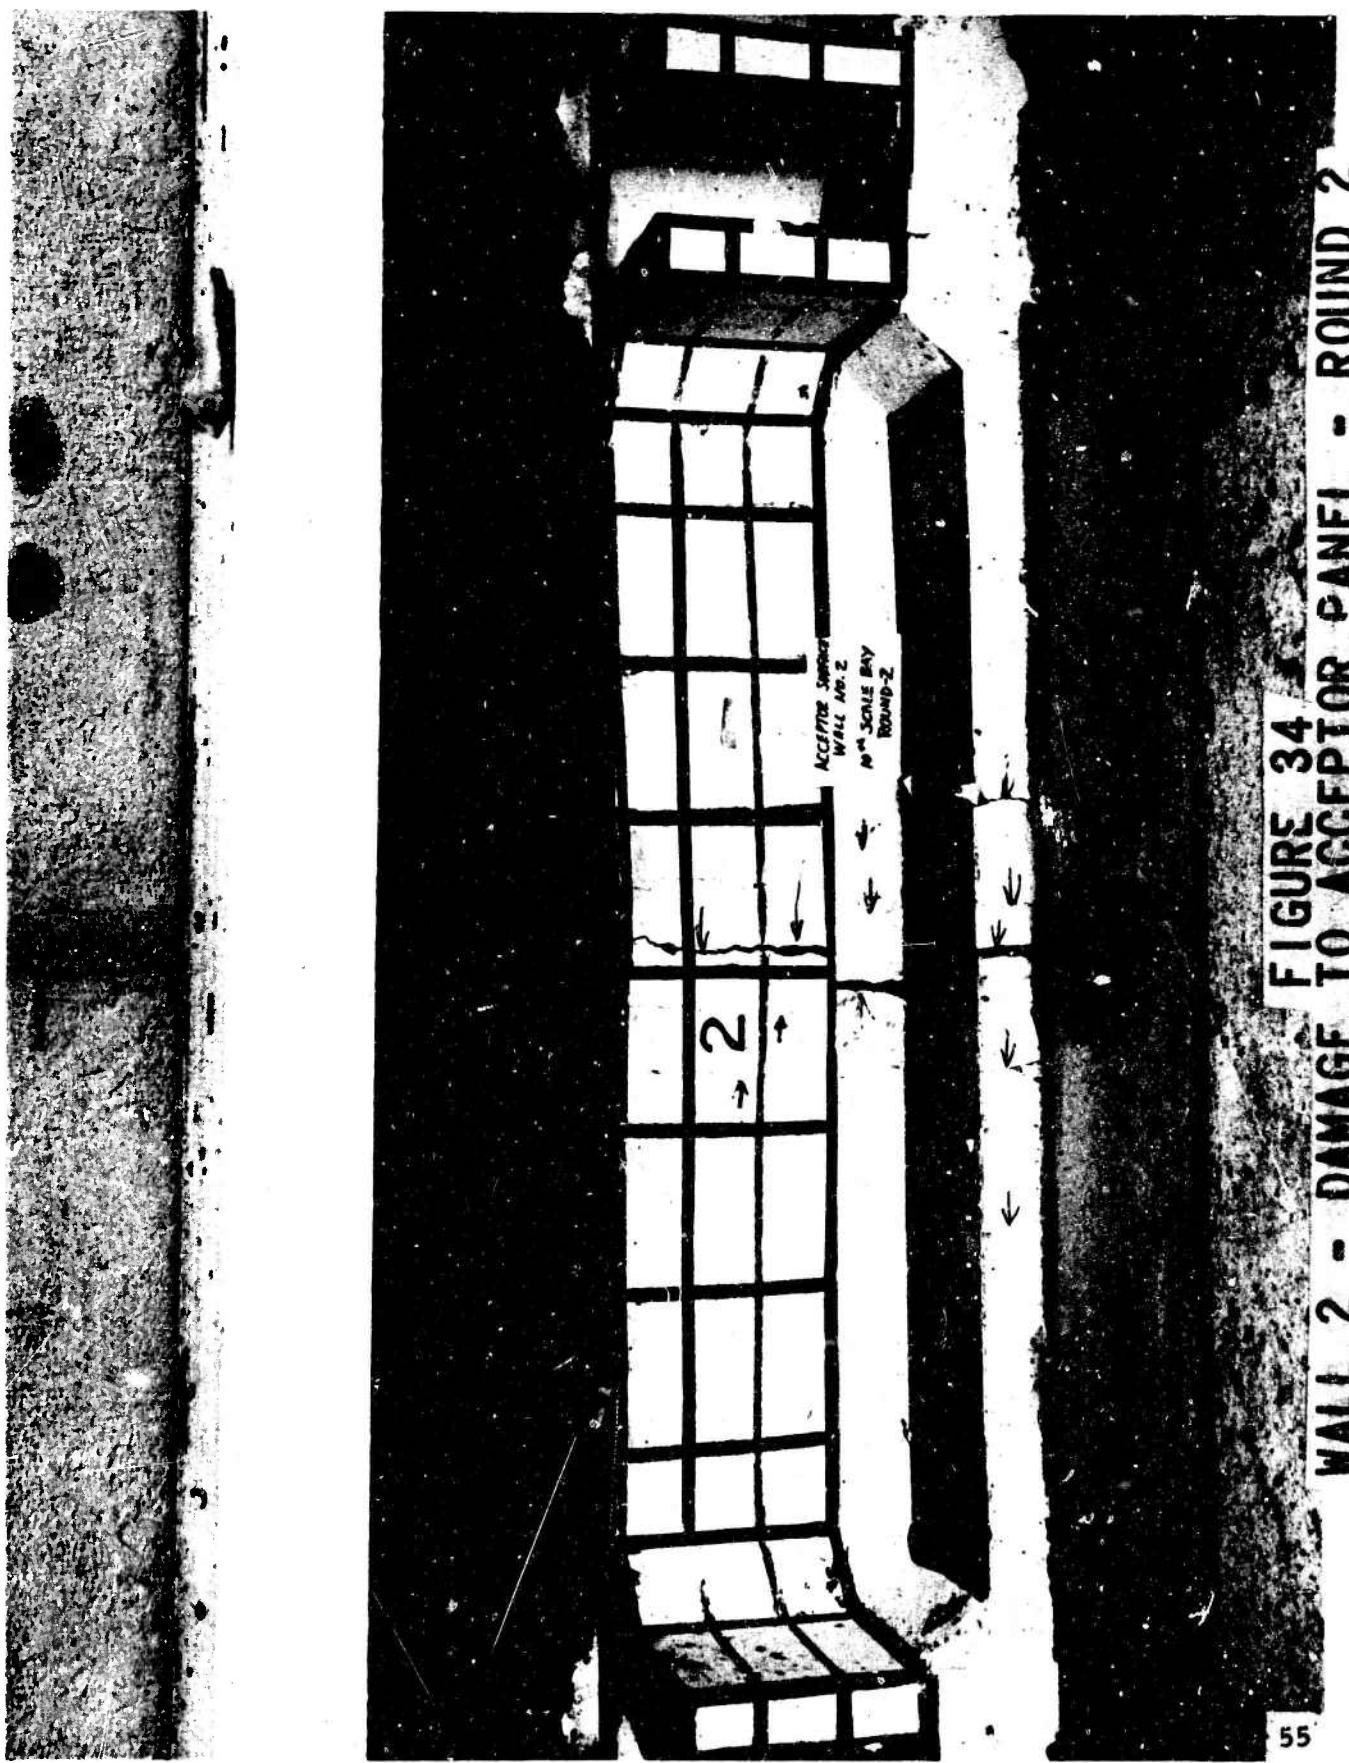
FIGURE 34
WALL 2 - DAMAGE TO ACCEPTOR PANEL - ROUND 2

Damage to Wall 2 was very extensive in the donor panel (Figure 33) and relatively light in the acceptor panel (Figure 34). Reinforcement was bared over a considerable area of the donor surface of the donor panel and over more than 50% of the top surface of the same panel (Figure 33). Extensive cracking was visible throughout the

donor panel but only one principal crack appeared on the acceptor panel; however, the latter crack which had a width of 1/2-inch not only traversed the haunch but also extended through the full thickness and length of the floor slab of the acceptor cell.
